# ACCESSIBILITY FOR PERSONS WITH DISABILITIES: GLEANINGS FROM THE TWO MOTORWAY INTERCHANGES IN ACCRA, GHANA

**Keywords:** Persons with disabilities, Interchange, Accessibility, Sustainable Development Goals.

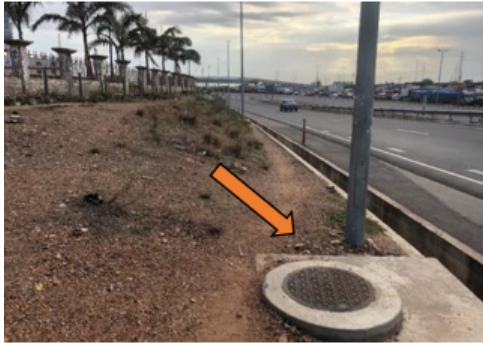
**Figure 5:** Walkway covered by manhole

According to Ghana Standards Authority (2016), walkways must be firm, level and non-slippery with a minimum recommended width of 1.675 m to ideally allow two wheelchairs or scooters to pass by. Some walkways on the Interchanges, especially TMI, were quite narrow and did not meet this requirement (Figures. 5 - 7). For those that had widths of up to 4.2 m, parts of them were encroached by hawkers, refuse, pavement blocks, debris and open drains (Figure. 6). This situation is definitely inimical to the safety of PWDs, especially users of white canes, clutches and wheelchairs. This implies that, beyond adhering to the design standards provided, city managers and the highway authorities need to demonstrate an appreciation of the principles that informed the designs by decongesting these areas for the free movement of pedestrians.

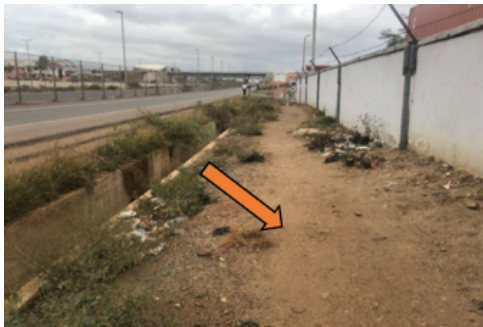
**Figure 6:** Unpaved Pedestrian Walkway with opendrains at TMI

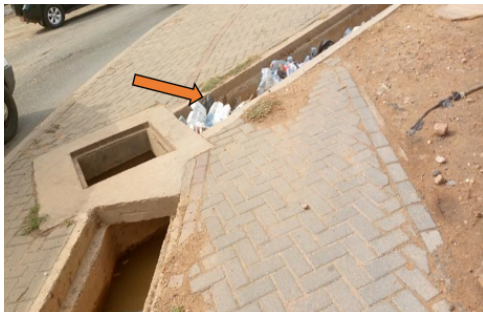
**Figure 7:** Walkway at TQI with open drains and uncovered manholes

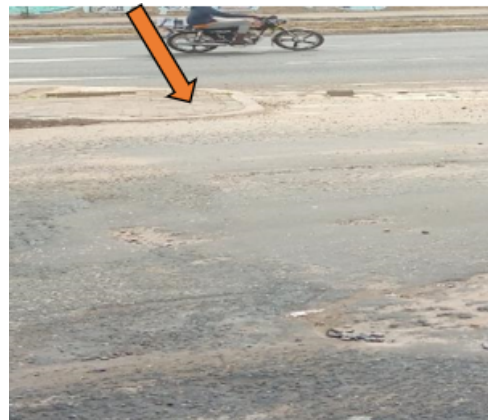
**Figure 8:** Refuge island with kerb ramp (TQI)

designs where there is a level difference between the pedestrian pathway and the surface of the road. Furthermore, they should be of non-slip materials, have a gentle slope, be provided at both ends of zebra crossings and be located such that they are well drained of rainwater and contain no manhole covers, storm gratings or other obstacles to free movement (GS 1119:2016 Subsection 2.1.3). The study revealed that kerb ramps, even where provided, were mostly on one side of the zebra crossings (Figures. 8 and 9).

Section 2.1.11 of GS 1119:2016, requires that traffic islands be provided at the requisite areas as safe havens for pedestrians. Crossings without refuge islands are not convenient for pedestrians; in many cases, they cross irregularly rather than wait for a vehicle to give them the priority (Mako and Szakonyi 2016) (Figures. 8 and 9). Yiing et. al (2017) asserted that all types of pedestrians prefer

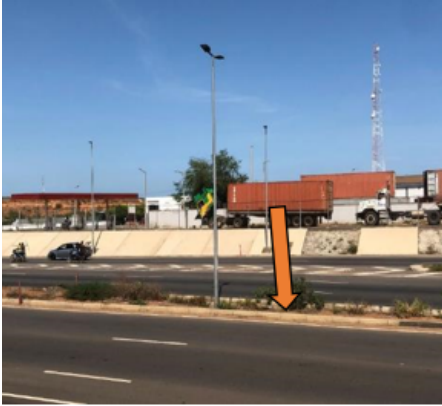
**Figure 9:** Refuge island without kerb ramp (TMI)

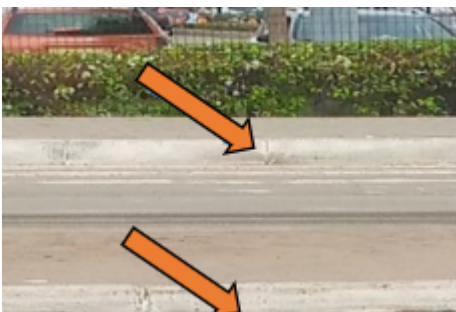
**Figure 10:** 42 cm high kerbs (arrowed)

The presence of refuge islands at signalised intersections and pedestrian crossings. Refuge islands should be at least 1.5 m wide and of materials and finishes that clearly distinguish them from the surrounding paving, especially for visually impaired persons. Apart from the footbridges and ramps, pedestrian crossings are the only means by which pedestrians can cross the interchanges. A pedestrian crossing that crosses a traffic island should be level with the main crossing or have kerb ramps, especially for persons with mobility challenges (United States Access Board, 2011). Refuge islands had been adequately provided at TQI and TMI and were in good condition but could not be accessed by PWDs due to the absence of kerb ramps (Figures. 10 and 11).

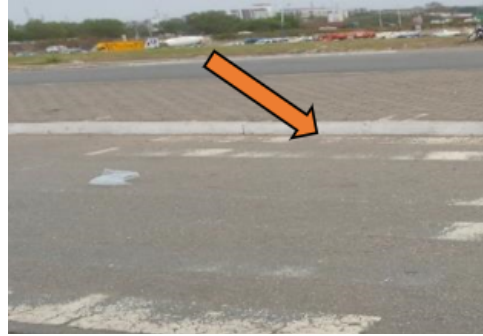
**Figure 11:** Kerb ramp on only one side of road  
*pedestrian crossing at (TQI) with faded pedestrian crossing (TQI)*

In section 5.5.1 of GS 1119:2016, provision is made for zebra crossings and pedestrian signals to help guarantee the safety and comfort of pedestrians, including PWDs. These should be designed in accordance with the Ghana Highway Code and should be provided with both audible and flashing crossing signals. For the sake of the elderly and PWDs, who will need more time to cross, there are to be pedestrian buttons mounted on poles and provision of tactile features among others. The study revealed that this was far from the reality because several of the pedestrian crossings, even where present, especially at TQI, had faded (Figure. 11) and pedestrians who avoided the use of the pedestrian bridges had to run across the roads to avoid being hit by speeding vehicles. PWDs found it difficult to cross these roads at these sections. This is a serious issue because, according to Kadzim (2012), PWDs normally felt safer crossing roads at marked crossings and pedestrian bridges. Mako and Szakonyi (2016) concluded that the two main driver errors at pedestrian crossings are speeding and not giving priority to pedestrians. WHO (2013) however, asserted that marked pedestrian crossings should not be implemented without additional safety measures. Pedestrians may falsely assume that they are safer and that motorists are more likely to see them and stop at marked

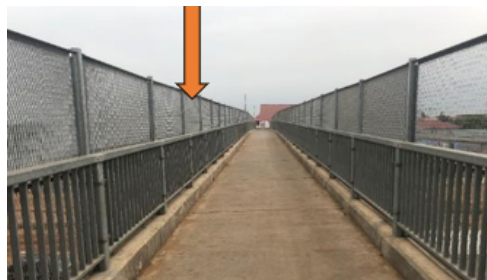
**Figure 13:** Disability pedestrian ramp enclosed by footbridge Ramp handrails on both sides (TMI)

Sawyer and Bright (2007) emphasised the need to provide suitably designed and constructed ramps to all users of the built environment, especially PWDs. The TMI interchange has a footbridge comprising a staircase and a disability pedestrian ramp on each of its three legs with the fourth leg having only a disability pedestrian ramp. At TQI the footbridges have both staircases and disability ramps. Henry (2009) indicated that the provision of ramps, suitable toilets and handrails enhances the provision of accessibility to PWDs. The gradient of the ramps, finishes and handrails at TQI and TMI were in conformity with the Standards; the ramps had rough non-slip finishes with handrails above the minimum 0.865 m (Figures. 12 and 13) and the gradients were not steeper than 1:12 as stipulated by Ghana Standards Authority (2016) and Solidere (2004). While Cullen (2006) insisted that tactile surfaces are indispensable for the safe passage of partially and completely blind persons in the built environment, the Disability Standards for Accessible Public Transport (DSAPT) (2002) requires that tactile ground surface indicators must be installed on an access path to indicate stairways, ramps, changes of direction, overhead obstructions below a height of 2000 mm, and

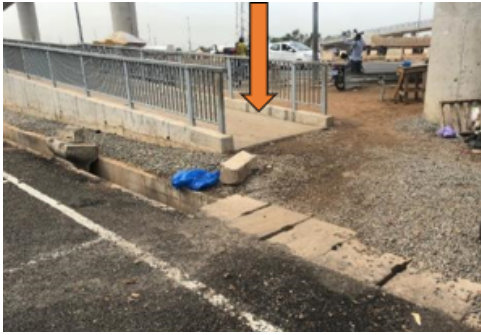
**Figure 14:** Entrance to a footbridge ramp at TMI with loose gravel and open drains gravel surface and open drains

Unfortunately, tactile surface indicators were completely absent at the two interchanges, and this will pose a potential harm to the blind since they will find it difficult to detect obstructions in their paths when using the interchanges. The lack of tactile surface indicators at the foot of the footbridges is further compounded by the presence of loose gravel and open drains (Figures. 14 and 15) at the entrance of some footbridges, which will make accessibility very cumbersome for the PWDs. Some motorbike riders use the ramp for crossing the road at the footbridge (Figure. 12) and this poses a big risk to PWDs who use the footbridge at TQI. The managers, law-enforcing agents, and other stakeholders of the interchanges should ensure the cessation of this unlawful practice since it poses a serious hazard to PWDs who use the ramps to cross the roads.

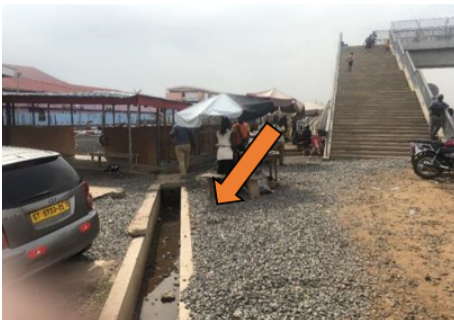
**Figure 15:** Access to a staircase at TMI with loose

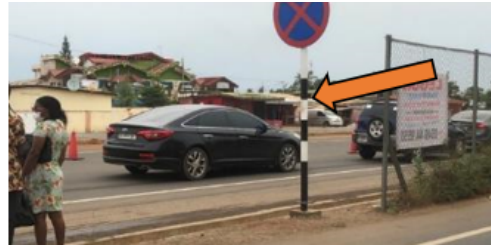
**Figure 16:** Signage at TMI in a relatively better state

The GS 1119:2016 Standard requires that comprehensive exterior signage and wayfinding systems be provided to assist users in locating appropriate facilities and finding their way (Section 2.5.4). These should be of appropriate letter sizes and located at appropriate heights (Figure. 16). At the interchanges, aside from the challenge of selective provision, there was evidence of poor maintenance culture where some damaged or missing signs were yet to be replaced. Secondly, some pedestrian crossings were faded, putting pedestrians, especially PWDs, at risk (Figures 11 and 17). The international disability symbol, which is used to convey the needs of PWDs in signage, was completely missing at the two interchanges.

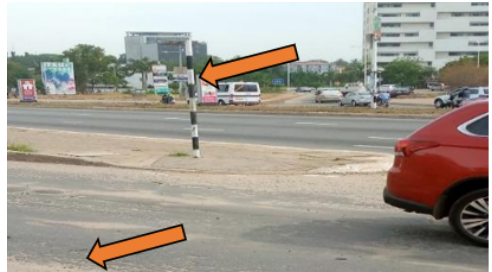
**Figure 17:** Damaged signpost and faded Pedestrian crossing (TQI)

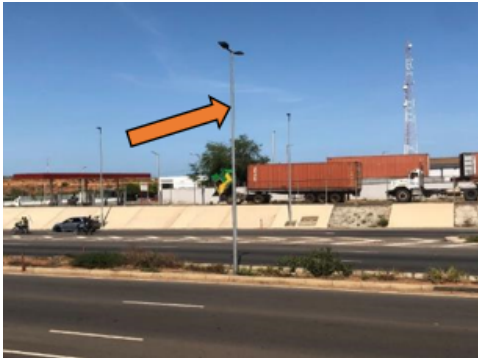
Figure 18: Streetlights at TMI

According to Road Planning and Design Manual (2004), the objective of major road lighting is to provide a lighted environment that is conducive to the safe and comfortable movement of vehicular and pedestrian traffic at night. However, the visual requirements of the motorist predominate. To accomplish this, the lighting should reveal necessary visual information. This will consist of the alignment of the road ahead, kerbs, footpaths, road furniture and surface imperfections, together with other road users, including pedestrians, cyclists and vehicles, and their movements, and any other animate or inanimate obstacles (Department of Transport and Main Roads, Queensland Government., 2021). Adequate provision had been made for street lighting at TQI and TMI but their maintenance was lacking especially at TQI where some of the lights were not functioning at the time of the study. This made the use of such places quite dangerous for PWDs during dark periods especially those with various degrees of visual impairments. TMI was relatively better and well-lit at night (Figure. 18 and 20).

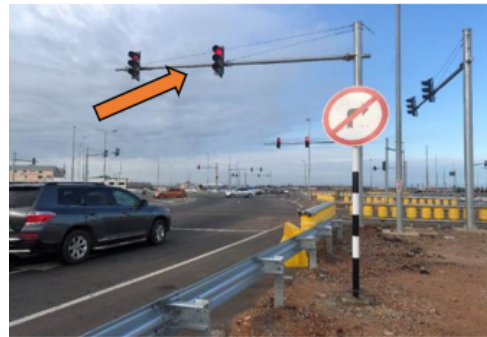
Figure 19: Traffic Signal at TMI

Oskarbski *et al.* (2016) noted that traffic signals/lights are one of the most effective means of controlling traffic and are used to segregate colliding traffic movements at intersections and a very critical element of pedestrians' service at the signalised intersection is to give them sufficient time to pass a pedestrian crossing. Their design is contingent upon two important parameters, namely the speed and volume of pedestrians and vehicles and pedestrian commuting plays an important role for various people, including some vulnerable groups such as the elderly and children with PWDs. Traffic signals at the two interchanges were also in a satisfactory state at the time of the study (Figure. 19). From the foregoing, the TMI was more accessible than the TQI as far as signage, street lights and traffic lights are concerned.

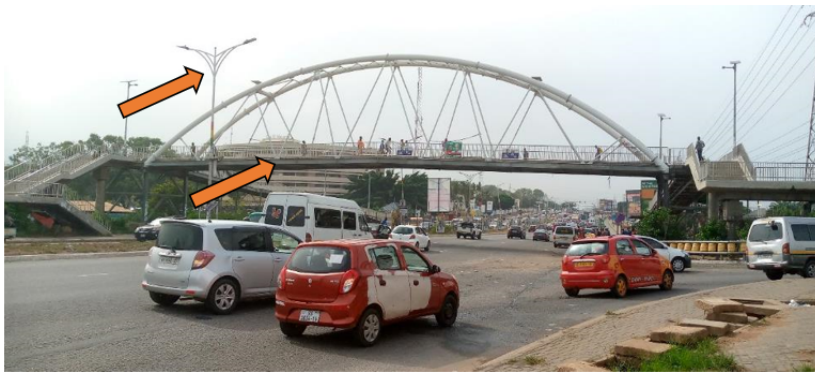
Figure 20: Footbridge and Streetlights at TQI

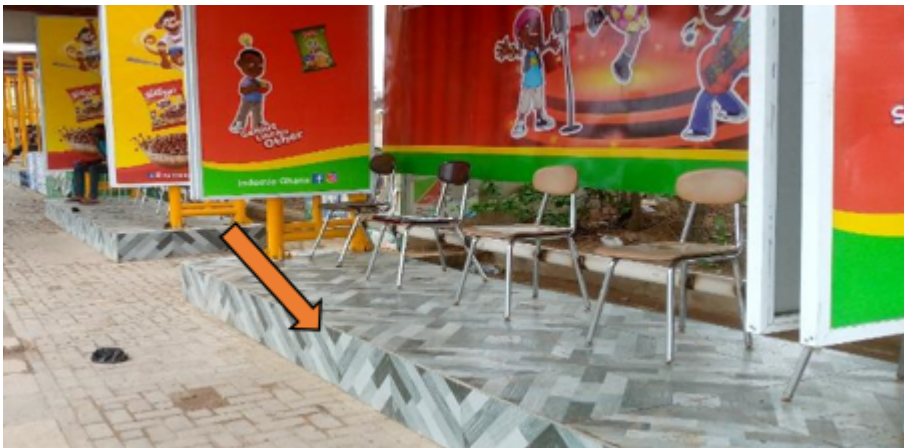
had raised platforms (Figure. 21), making them inaccessible to wheelchair users. Lacey (2004) emphasised that accessible parking spaces are imperative because cars are sometimes the only practical transport system for some disabled people. Bezzina and Spiteri (2005) and BS8300 -2 (2018) stated that car parking and setting down are important activities at the beginning or the end of journeys. Solidere (2004) identified the main problems with the provision of parking spaces as poor parking facilities, insufficient width of the parking aisle and no allocation of parking space for the disabled.

**Figure 21:** A bus shelter at TQI with a raised platform of 0.4m

with a minimum kerb height of 150 mm. Shelter structure if provided, should not obstruct access paths and walkways and must be fitted with a minimum light level of 150 lux, a Bus Stop sign and a Tactile Ground Surface Indicator. 5% of seats (minimum of 2) to be identified as priority seating for PWDs (DSAPT, 2002; Australian Human Rights Commission Accessible Bus Stops Guidelines, 2010). The two interchanges had few bus shelters and car parks/parking spaces but they all had firm, level and well-drained bases as required by GS 1119:2016 section (2.2.2). However, some bus shelters

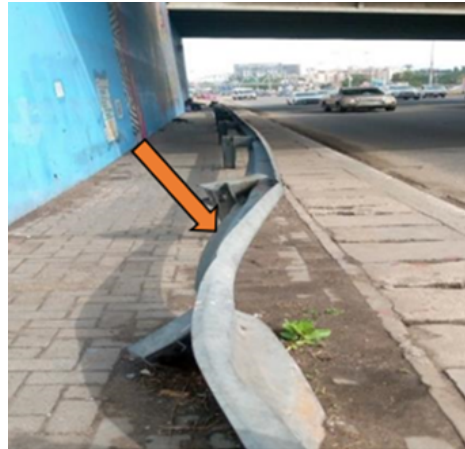
Figure. 23 Damaged and mangled crash barrier in poor condition at the TMI barrier at TQI

Street furniture consists of items such as crash barriers, rubbish bins, planter boxes, public seats/benches, telephone booths, bollards, gates, lamp posts, fire hydrants, direction and street signs etc. that are normally located on both vehicular and pedestrian routes. Per GS 1119:2016, all public pedestrian routes should be designed to ensure the safety and comfort of all persons regardless of age or ability (section 2.1.11). Some essential street furniture such as rubbish bins, public benches and telephone booths was virtually absent from both TQI and TMI. As mentioned earlier, other types of street furniture such as signage, traffic lights, street lights and crash barriers (Figures. 22 and 23) were poorly maintained and in a state of disrepair especially at TQI and this calls into question the culture of maintenance of the relevant state institutions and stakeholders. Facilities that ensure accessibility of PWDs to the interchanges may be provided, but may be of little or no use if not properly maintained.

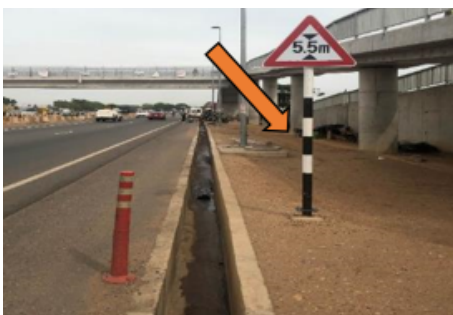
Figure 22: Various road furniture in relatively
