## COMMON CAUSES OF LEAKAGES IN PARAPET ROOF CONSTRUCTION IN GHANA: A CASE STUDY FROM KUMASI

### ABSTRACT

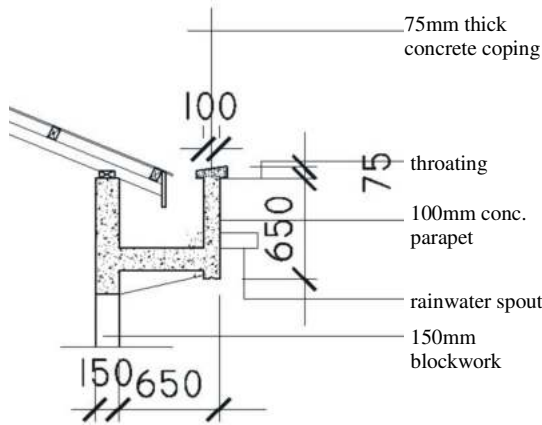
Fig. 2: A typical cantilevered roof gutter with a parapet wall

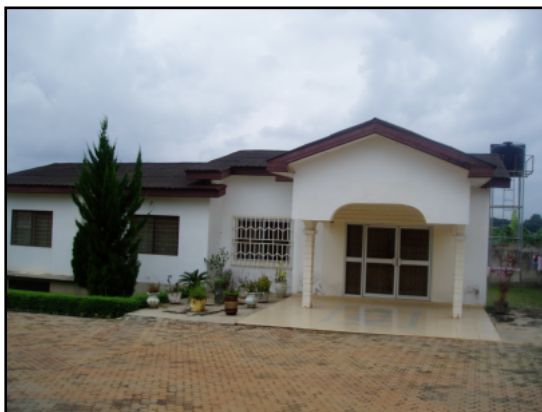
Plate 1 A building without roof parapet walls

A pitched roofs could still have the roof edges or eaves exposed or hidden with a concrete fascia or parapet if it is so required (Plates 1 and 2). There are several reasons for the use of parapet walls. A designer could use them to articulate the aesthetics and character of a building. It must not, however, be mistaken here that the sole purpose of roof parapet walls is to hide the roof coverings of buildings. Functionally and technically, it is a practical way of collecting and channelling storm water to specific areas for collection and storage or appropriately discharged through rain gutters, especially, for multi-storey buildings, where rain water falling from great heights, may create serious erosional activities and soil degradation. They could also be employed in areas where strong winds, have the tendency of blowing roofs off buildings.

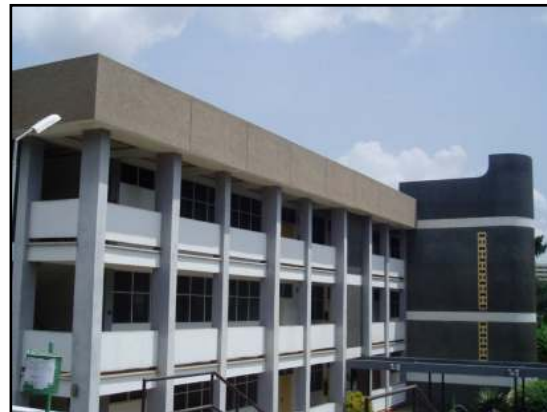
Plate 2: A building with roof parapet walls

laterally meaning 'construct it inside' or more appropriately, 'hide it inside' (Plate 2).

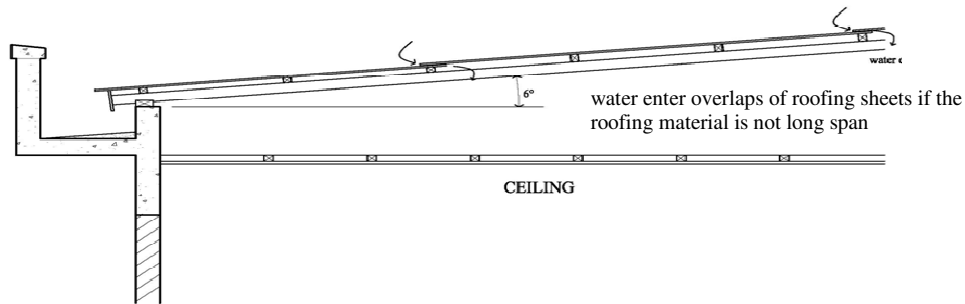
The problem that this roof is normally associated with is, basically, that of leakage during rainstorms. Most local artisans are usually baffled by this kind of leakage, since it usually occurs at the overlaps or junctions of the corrugated roofing sheets used. Due to the almost flat nature of the roof, rainwater stays slightly longer on them than it would on a pitched roof, as such water

enters through the overlapping sheets by capillary action and drip onto the ceiling of the building into rooms below (Fig. 3).

Fig 3: Low-pitched roofing and the risk of leakage through the overlaps of the roof coverings

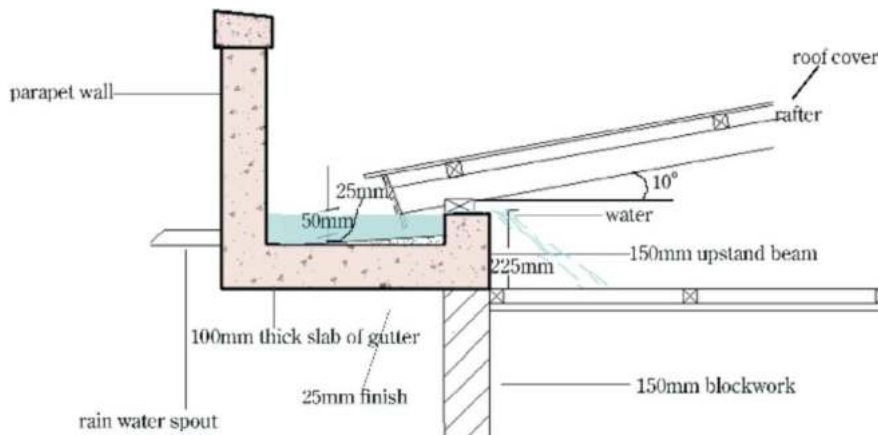
Figure 4 shows a detail drawing of a roof gutter, parapet and the eaves of a typical parapet roof. It would be observed that it has everything that would make it function as a roof gutter. However, a critical assessment would reveal certain basic flaws, which may result in a leakage.

A ring beam of about 150mm x 225mm supports and anchors the rafters. The concrete slab of the gutter is about 150mm thick, supporting a parapet wall of 100mm. This, therefore, means the depth of the gutter, has been reduced to about 75mm. With a cement/sand screed finish of

Fig. 4: A reduction in the height of the upstand beam and the risk of water entering the roof space

about 25mm thick laid to fall, it would be further reduced to 50mm deep. This therefore means, the critical depth at the beam end of the gutter available for rainwater collection, is only 50mm. This situation would definitely result in leakage problems during heavy rainstorms when water, collected in the gutter, rises quickly and goes over the edge of the beam (i.e. under the wall plate into the ceiling space). In most of the leaking roofs encountered in practice and during the study, the water does not drip directly onto the ceiling. To the annoyance of the occupants, it drips along the walls, thereby making it difficult to collect the drops in a container. During the study, a landlady indicated that she always leaves the house in the rainy season with pieces of cloth lined along the base of the walls which drip with water, in order to soak the water in case it rains in her absence.

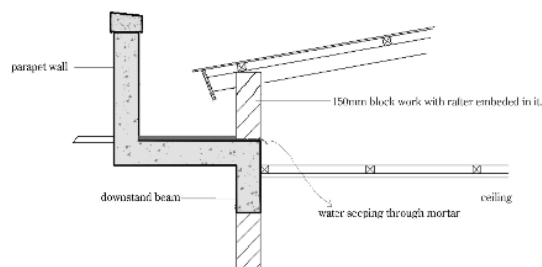
Figure 5 shows that the workmen have wrongly constructed a downstand instead of an upstand ring beam. In this particular instance, the leakage comes about when rainwater slowly seeps through sand/cement screed laid to fall in the gutter itself and then goes through the mortar

**Fig. 5: Parapet Roof with a Downstand beam**

joint between the block work and the downstand beam. This type of leakage may take a longer time to manifest if the sand/cement screed is rich, but it would eventually occur.

This problem could also be dealt with by removing the existing sand/cement screed, which has been laid to fall in the gutter, and lay a richer mix of same, (e.g. a mix of 1: 3) with a greater slope such that water does not stay near the wall on which the roof members are anchored, with the necessary waterproofing on the surface as required. However, if in the design there is the need for a downstand ring beam due to structural considerations, a concrete upstand of, at least 150mm high, could be constructed (on top of the downstand beam) before any block work. This would help contain any water and prevent seepage due to its monolithic nature (Fig 9).

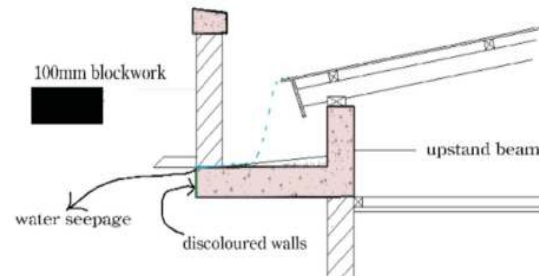
leakage occurs outside the building rather than into the interior space. Figure 6 shows a detailed drawing of a parapet wall built entirely of

**Fig. 6: The use of block work instead of reinforced concrete for a parapet wall**

100mm thick block work, while Plate 3 shows a picture depicting it as constructed. This practice is usually to help reduce cost of construction, since in this instance, concrete and reinforcement bars are eliminated.

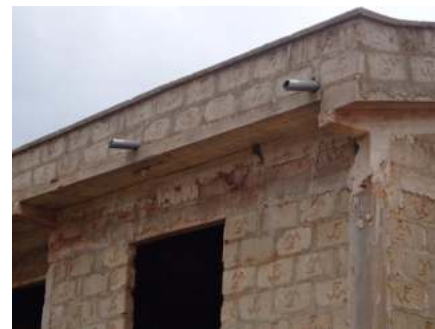
**Plate 3: Example of the use of sandcrete blocks in constructing a parapet wall.**

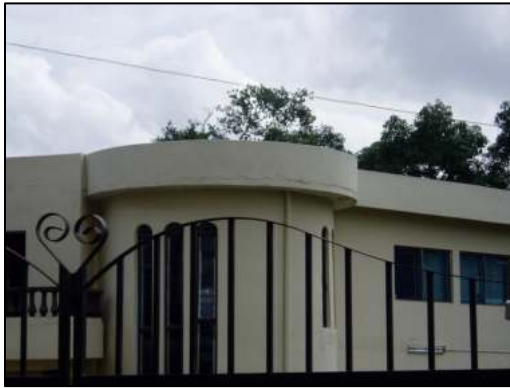
Here the problem is seepage of water between the mortar joint under the parapet of block work and the reinforced concrete base of the gutter. This causes discolouration on the exterior surface (of the lower portion of the façade of the parapet,) and destroys the aesthetic quality of the paintwork, in addition to the manifestation of a thin crack in the plaster, at the junction where the blockwork meets the concrete slab (Plate 4).

**Plate 4: Shows a crack in the cement/sand plaster where the blockwork meets the concrete slab**

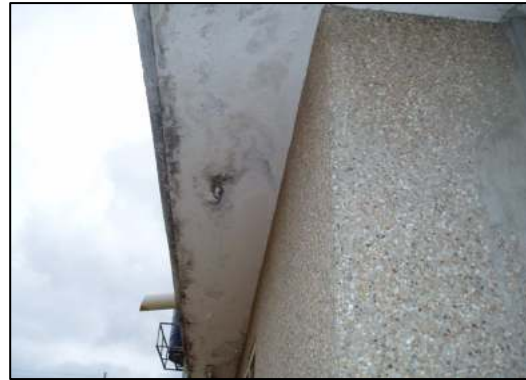
crete base of the roof gutter when water stays too long on it. This may be due to inadequate falls in the gutter, a poor mix of the sand/cement screed or the concrete itself used in constructing the gutter.

This kind of seepage would rust the reinforcement bars within the concrete and weaken them. It may eventually cause it to collapse but before this happens, discolourations of the soffits of the gutters occur, with the plastering falling off in bits and pieces (Plate 5).

**Plate 5: Discolourations due to seepage**

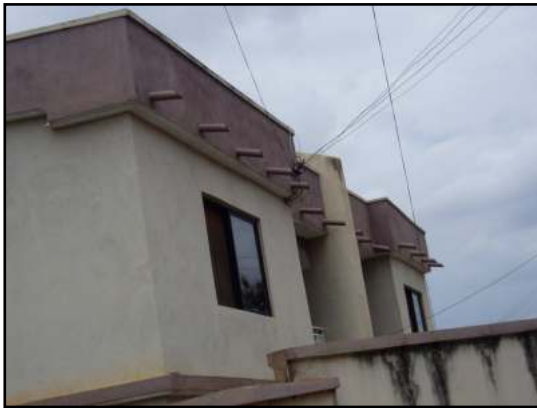
**Plate 6:** Shows the introduction of extra rain water spouts in the parapet walls of the roof to solve the problem of leakage.

With this problem, the easiest solution that could be effected is to introduce extra and/or bigger rainwater spouts to help the quick exit of water from the gutters (Plate 6). Another solution would be to widen the width of the gutter itself, if it is found to be too narrow. That would however, entail greater costs.

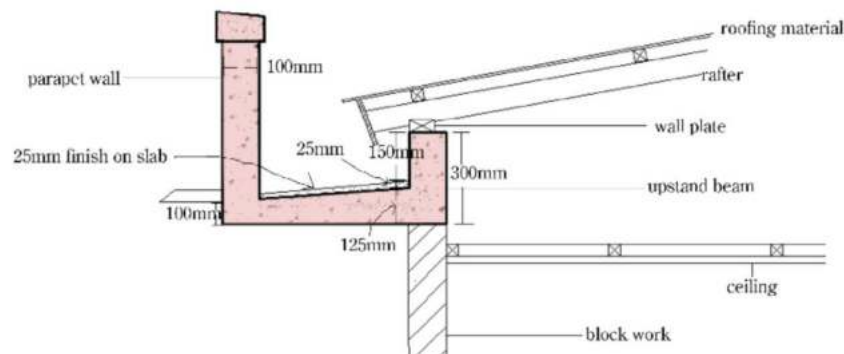
However, to forestall any leakage, parapet roof gutters should be designed or constructed such that they are wide and deep enough (at least 400mm and 300mm, respectively). The number of rainwater spouts should also be enough, (depending on the area of the roof) and regularly spaced to help water exit quickly. An innovation that could be used is by redesigning the gutter itself such that the point at which it is connected to the ring beam is thicker than the edge on which the parapet wall sits (Fig. 8).

In effect, the concrete base on which the parapet wall sits is sloped. In this instance, stormwater would exit as fast as is necessary and would not rise to the level of the ring beam, since it could be rightly assumed that before that happens, all the water would have drained off through the provision of an effective system of water spouts.

**Fig. 8:** A wedge-like slab and an increase in the depth of the upstand beam as a solution to leakages

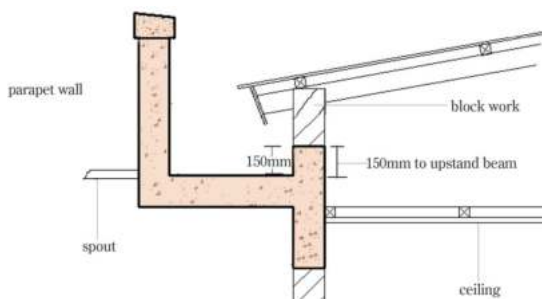
**Fig. 9: Use of both an upstand and a downstand beam in a roof gutter.**

The problem could be resolved by constructing a reinforced concrete parapet wall of about 75-100mm thick (Fig 9). However, in a bid to cut down cost, block work could still be used as shown earlier above. However, if block work is used, a concrete upstand beam of at least 150mm

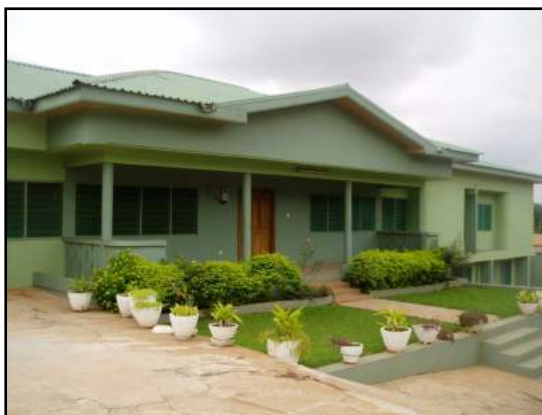
**Plate7: A building with a redesigned roof, eliminating the concrete gutter altogether**

Plate 7 shows the picture of a building, worked on by the author, which had a similar problem. The problem was so acute due to the poor nature of the detailing, blockwork, and mortar used, that almost all the walls inside, dripped with rainwater during rainstorms. Coupled with this was also the problem of seepage through the overlaps of the roof covering. It was technically a flat roof without long span roof covering. The existing parapet walls were removed and replaced with new (shortened) parapet walls (with a ring beam) and a redesigned pitch roof.

the parapet walls. Of the seven single-storey buildings studied, all were built in the early 1970's and had their ceilings in place, as such it was difficult to see the ring beam from within during the field work. The author had personally worked and resolved leakage problems on four of them, while the other three had had no history of roof leakages. Of the four whose problems of leakages were resolved, one had to change its entire roof covering from normal-sized corrugated aluminium sheets to long span roofing sheets. Two of these buildings had extra rain water spouts added to facilitate a quick evacuation of rain water in the roof gutters (Plate 6), while the last one had so acute a problem of leakage in almost all the rooms, that the parapet walls were shortened and constructed with a ring beam to enable a new, and completely redesigned pitched roof, to be built on it (Plate 7).

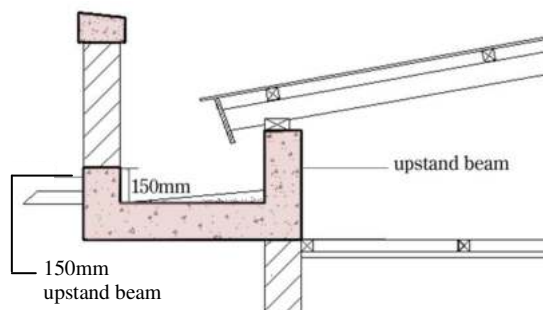
**Fig. 10: Use of 150mm high concrete upstand before the block work to solve seepage**

high should first be constructed on the concrete base of the gutter before the block work is added (Fig. 10). In other advanced countries like United Kingdom and the United States of America, this problem is usually forestalled by the use of a Damp Proof Course and metal flashing at this level (Chudley and Greeno, 2005).
